EVALUATION OF WATER DAMAGED EQUIPMENT

EH020 & REM025 MODEL WASHER-EXTRACTORS

The objective of this bulletin is to help identify potential component damage/ replacement due to exposure to water. This is only a guide and does not guarantee the restoration of functionality or the future durability of equipment.

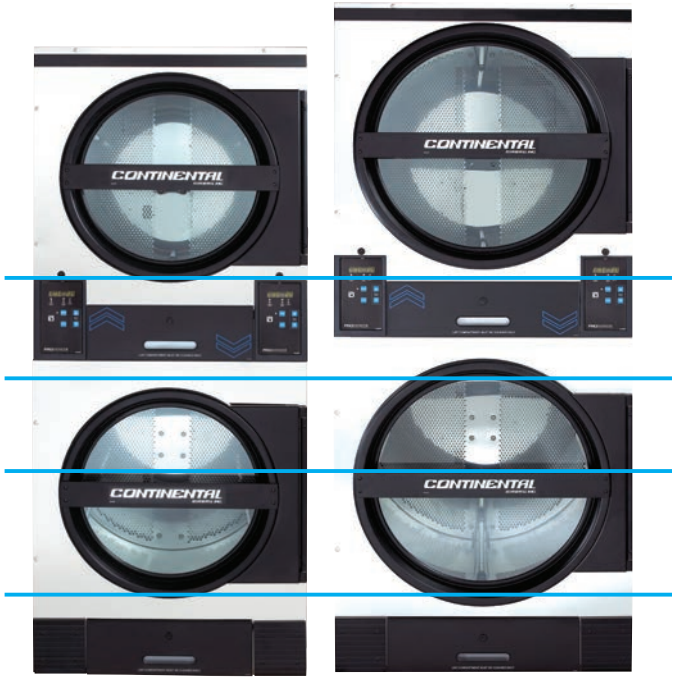
CG30X2 **CG45X2**

44”+
Gas Train, Upper Dryer

36”- 38”
Drum, Rear Bearing, Controls, Coin Drop, Air Flow Switch

24”- 36”
Fan Motor, Ignitor, Control Box Wiring, Door Switch, Front & Rear Seals

12”- 14”
Lint Screen, Drive Motor, Drum Rollers, Lint Drawer Switch

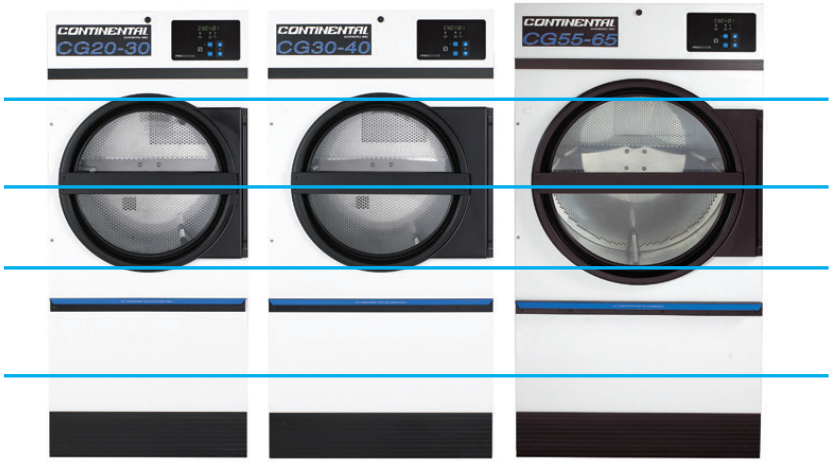
CG20-30 **CG30-40** **CG55-65**

44"+
Gas Train, Ignitor, Controls, Coin Drop, Control Box Wiring

36"- 38"
Drum, Rear Bearing, Air Flow Switch

24"- 36"
Drive motor, Lint Drawer Switch, Drum Rollers, Door Switch, Front & Rear Seals

12"- 14"
Fan Motor, Lint Screen

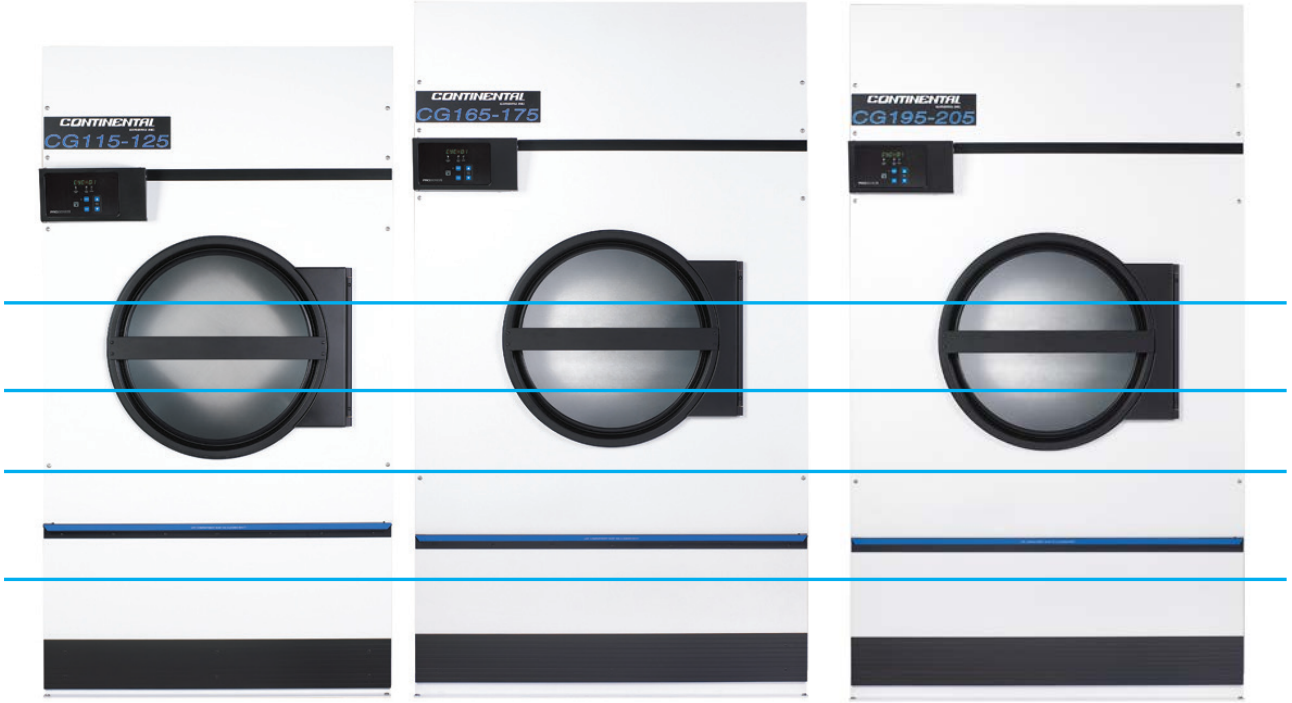
CG115-25 **CG165-75** **CG195-205**

44”+
Gas Train, Ignitor, Controls, Control Box Wiring

36”- 38”
Drum, Rear Bearing, Air Flow Switch, Door Switch, Drive Motor

24”- 36”
Lint Drawer Switch, Seals

12”- 14”
Fan Motor, Lint Screen
